Manhole Inspection Summary

Manhole # S45CC_044MH

Insp Date: **6/30/08 11:19 AM**

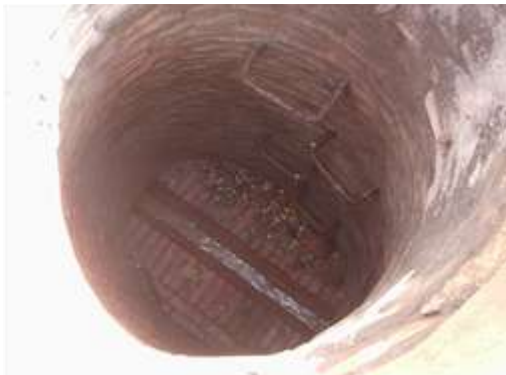
Defect 1

Infiltration: ☐ None ☐ Joint ☐ Cracks ☐ Mortar ☐ Roots ☒ **Wall**

Infiltration

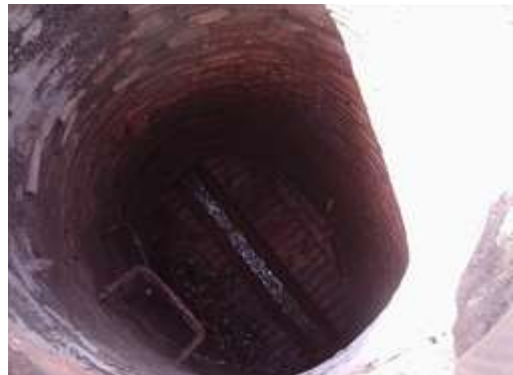
Defect 2

Condition: ☐ Sound ☐ Cracked ☐ Root Intrusion ☒ **Loose Brick** ☐ Deteriorated

Infiltration: ☐ None ☐ Joint ☐ Cracks ☒ **Mortar** ☐ Roots ☐ Wall

Loose Brick

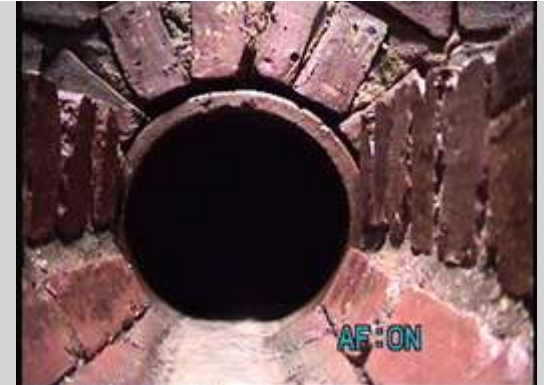
12 O'Clock Outflow

8 in. Circular Gravity Sewer
Pipe Out @ 12 O'Clock

Pipe Height: **8.4** (in.) Rod and Bar (Angled)
Pipe Material: **Clay** ☐ Pipe Lined
Invert Depth: **10.90** (ft.) Flow Characteristics: **Fast**
Deposits: ☒ None ☐ Mud ☐ Sludge ☐ Debris ☐ Grease
Silt Depth: (in.) Deposits Extent:
Infiltration: **None** Pipe Seal Cond: **Sound**

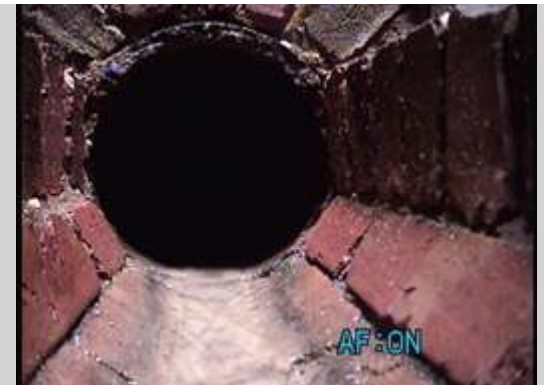
6 O'Clock Inflow

8 in. Circular Gravity Sewer
Pipe In @ 6 O'Clock

Pipe Height: **8.4** (in.) Rod and Bar (Angled)
Pipe Material: **Clay** ☐ Pipe Lined
Invert Depth: **10.70** (ft.) Flow Characteristics: **Fast**
Deposits: ☒ None ☐ Mud ☐ Sludge ☐ Debris ☐ Grease
Silt Depth: (in.) Deposits Extent:
Infiltration: **None** Pipe Seal Cond: **Sound**
